circa 1825-50

Catherine Rash Farm
Sudlersville vicinity
Private

INVENTORY FORM FOR STATE HISTORIC SITES SURVEY

Catherine Rash Farm

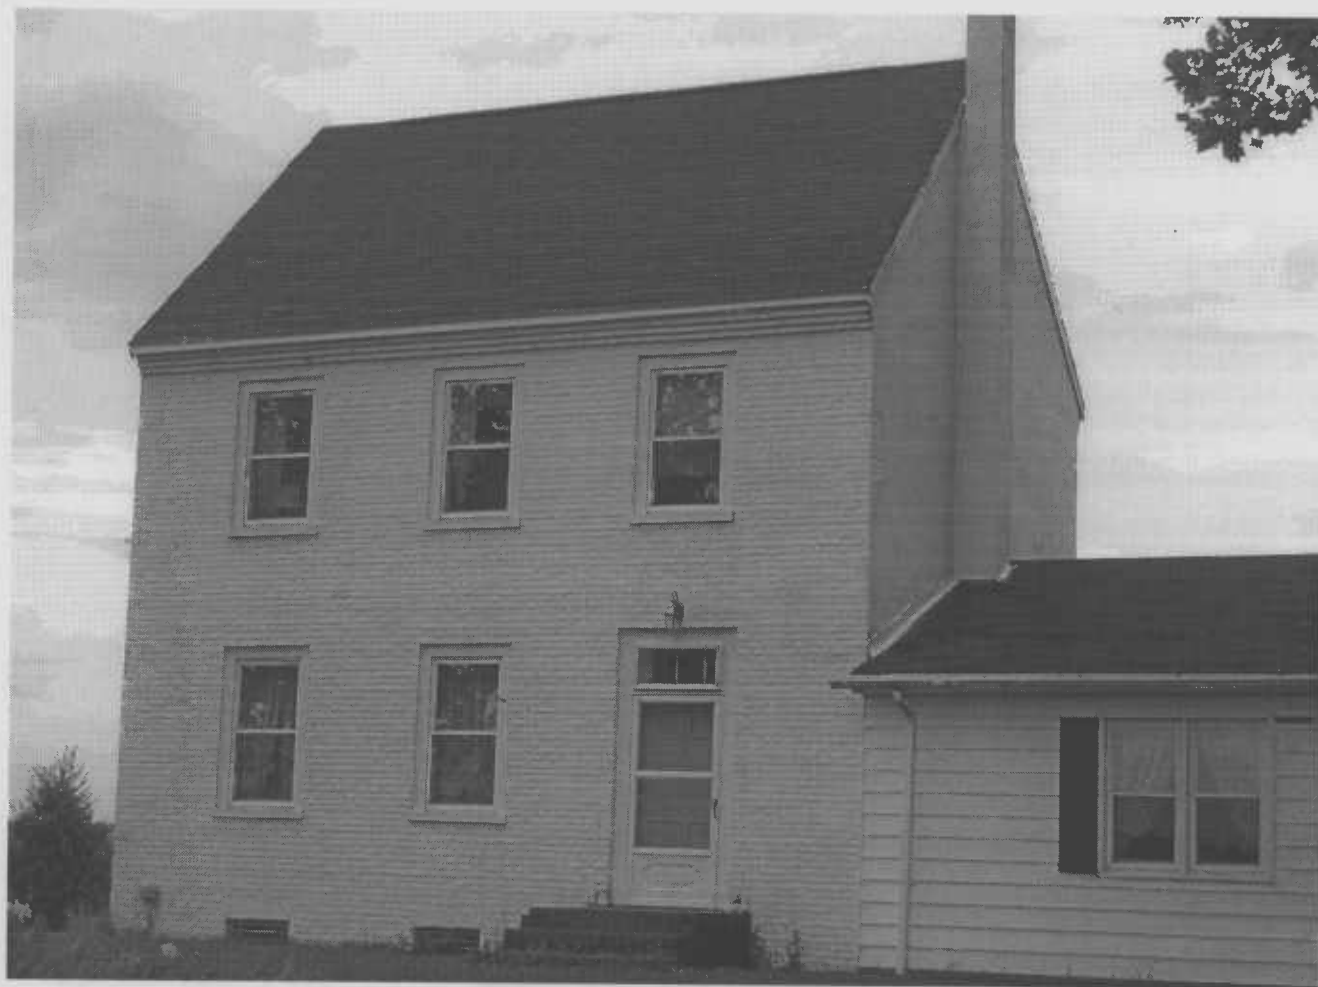
QA-40

Catherine Rash Farm

Mary McCarthy
Spring/Summer 2003
Digital color photo on file at MHT

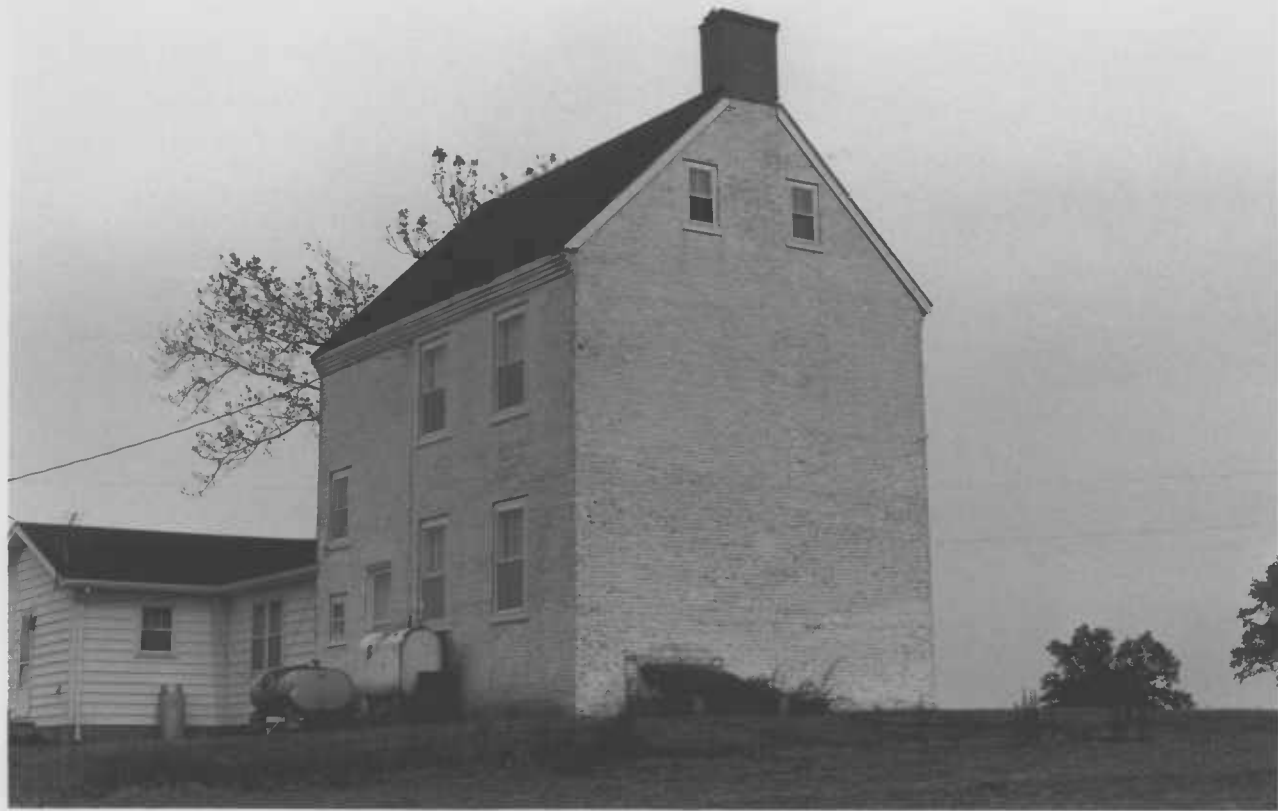
QA-40

The fenestration pattern is somewhat unusual on the north or rear facade. There are 6/6 windows in the center and west bays on both the first and second floors. To the east, there is a door on the first floor with a small four-light window to the left, and a larger 6/6 window downset on the second floor, directly above the four-light window. Both of these openings appear to be original. A single cellar window is centered in

the foundation; there are no dormer windows on the roof. The brickwork is laid in seven-course bond with a corbeled brick cornice identical to the front facade. The roof is covered with asphalt shingles.

Catherine Rash Farm
Sudlersville vicinity
Orlando Ridout V 1981
Rear facade from Northwest

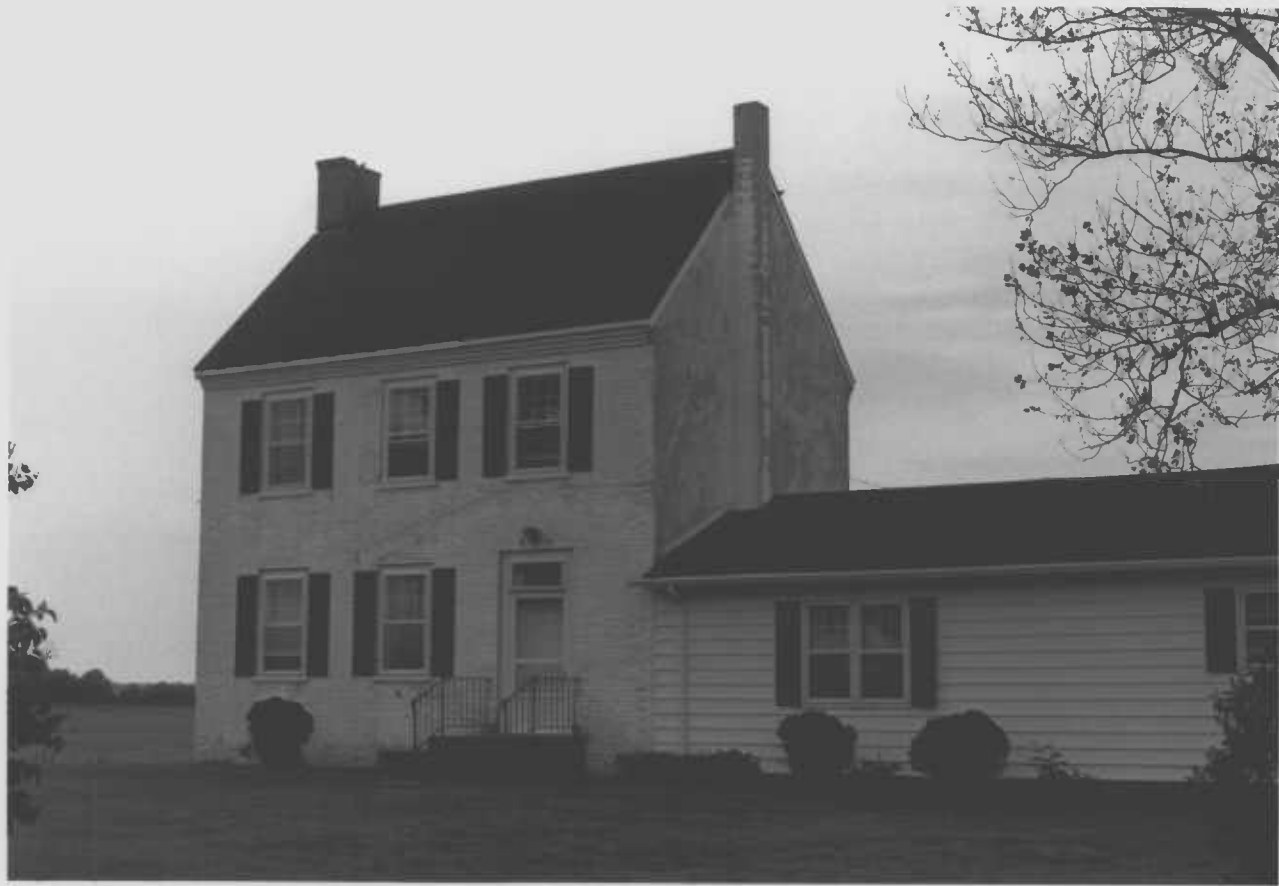
QA-40

The front facade faces south toward Route 300. It is three bays wide with a door in the east bay of the first floor, two 6/6 windows to the west of the door, and three 6/6 windows on the second floor. Small cellar windows are centered directly below the two first floor windows; there are no dormers. The window sash is original but the frames have been covered with aluminum flashing.

The six-panel door is a modern replacement, with an original three-light transom above. The brickwork is laid in Flemish bond above a common bond foundation with no water table or belt course. The cornice is corbeled out four courses with a fifth course set flush with the fourth or top course. The cellar window openings have splayed brick jack arches, all other openings are left plain. A ghost in the whitewashed brickwork indicates a one-story porch sheltered the two east bays on this facade at one time.

Catherine Rash Farm
Sudlersville vicinity
Orlando Ridout V 1981
Front facade from Southeast
